# Stormwater Considerations

## – West Elmira

# Fern Dell Drive Stormwater System

# Comprehensive Storm Drainage Studies

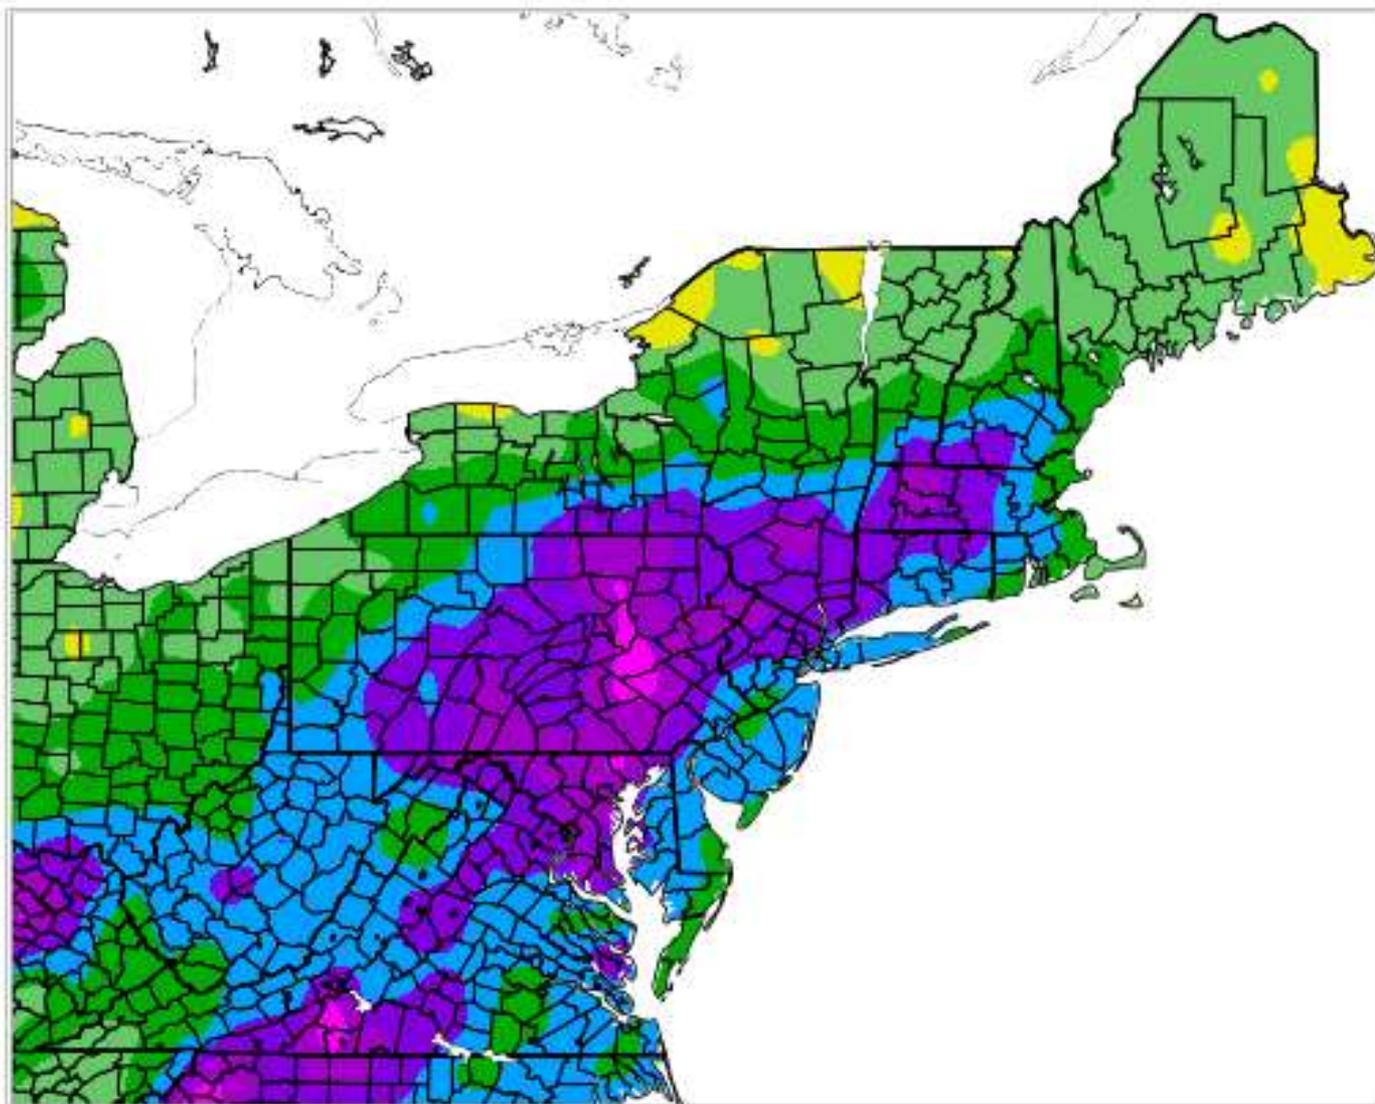
# Precipitation (in)

7/17/2018 – 10/14/2018

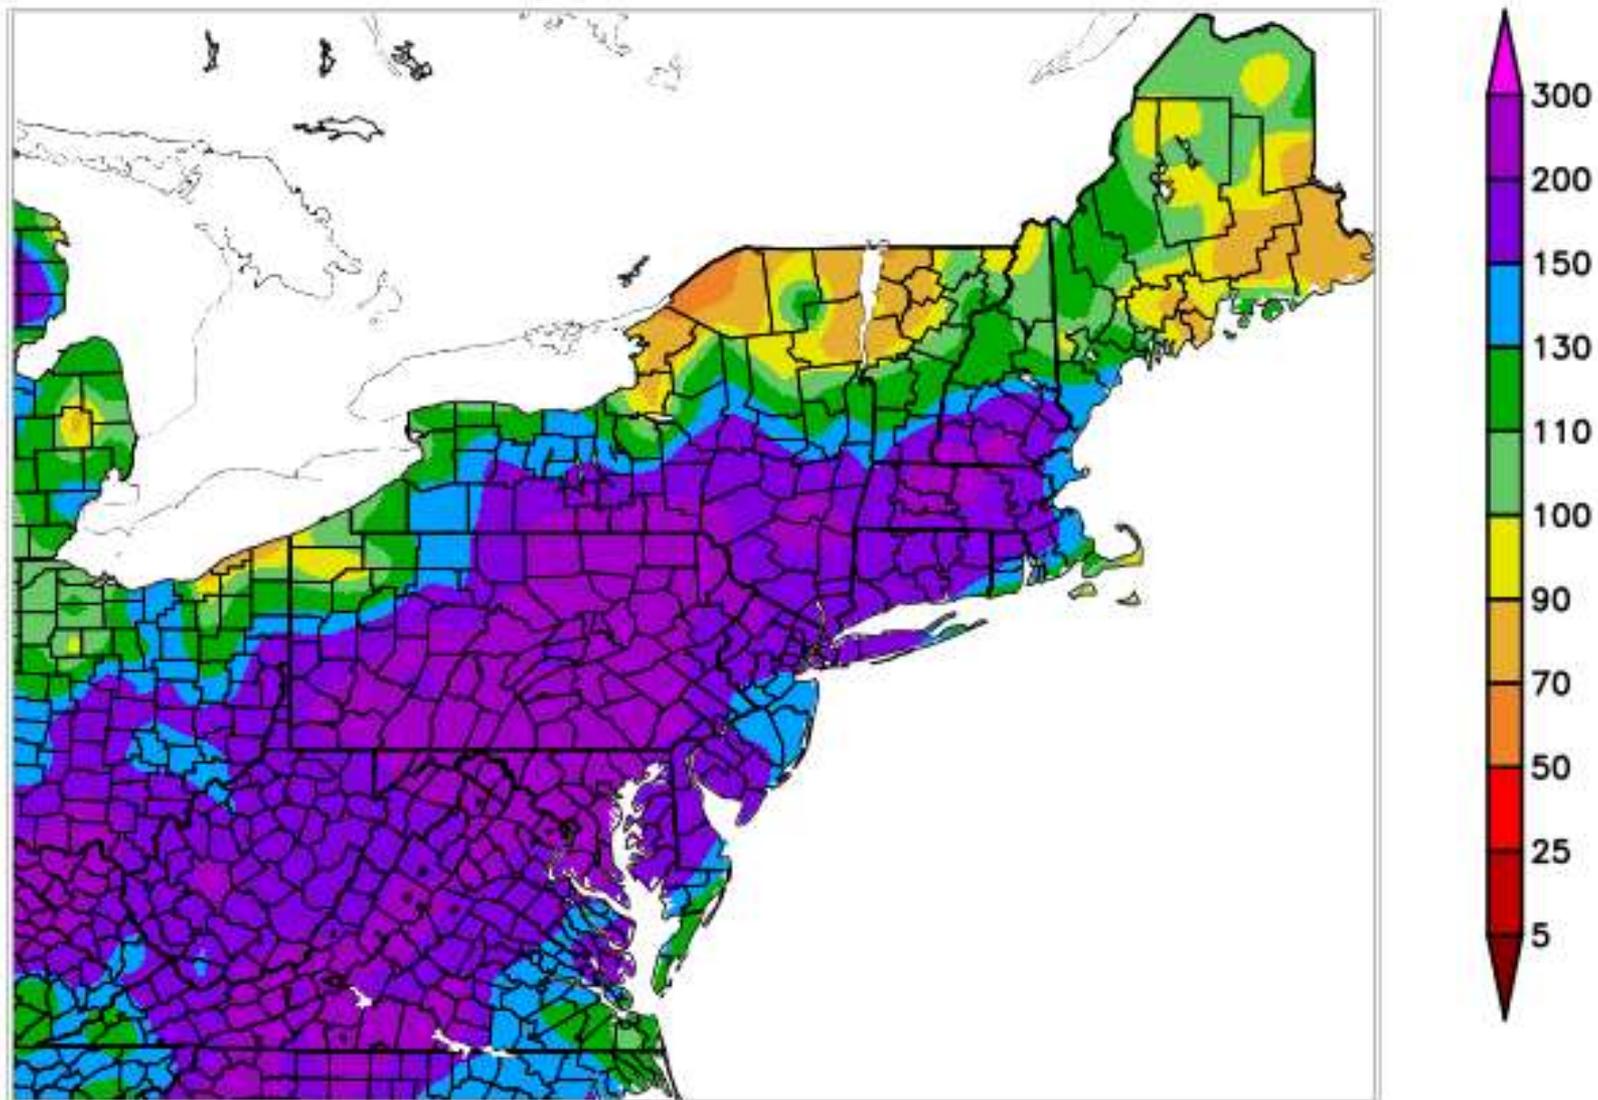
# Percent of Normal Precipitation (%)

## 7/17/2018 – 10/14/2018

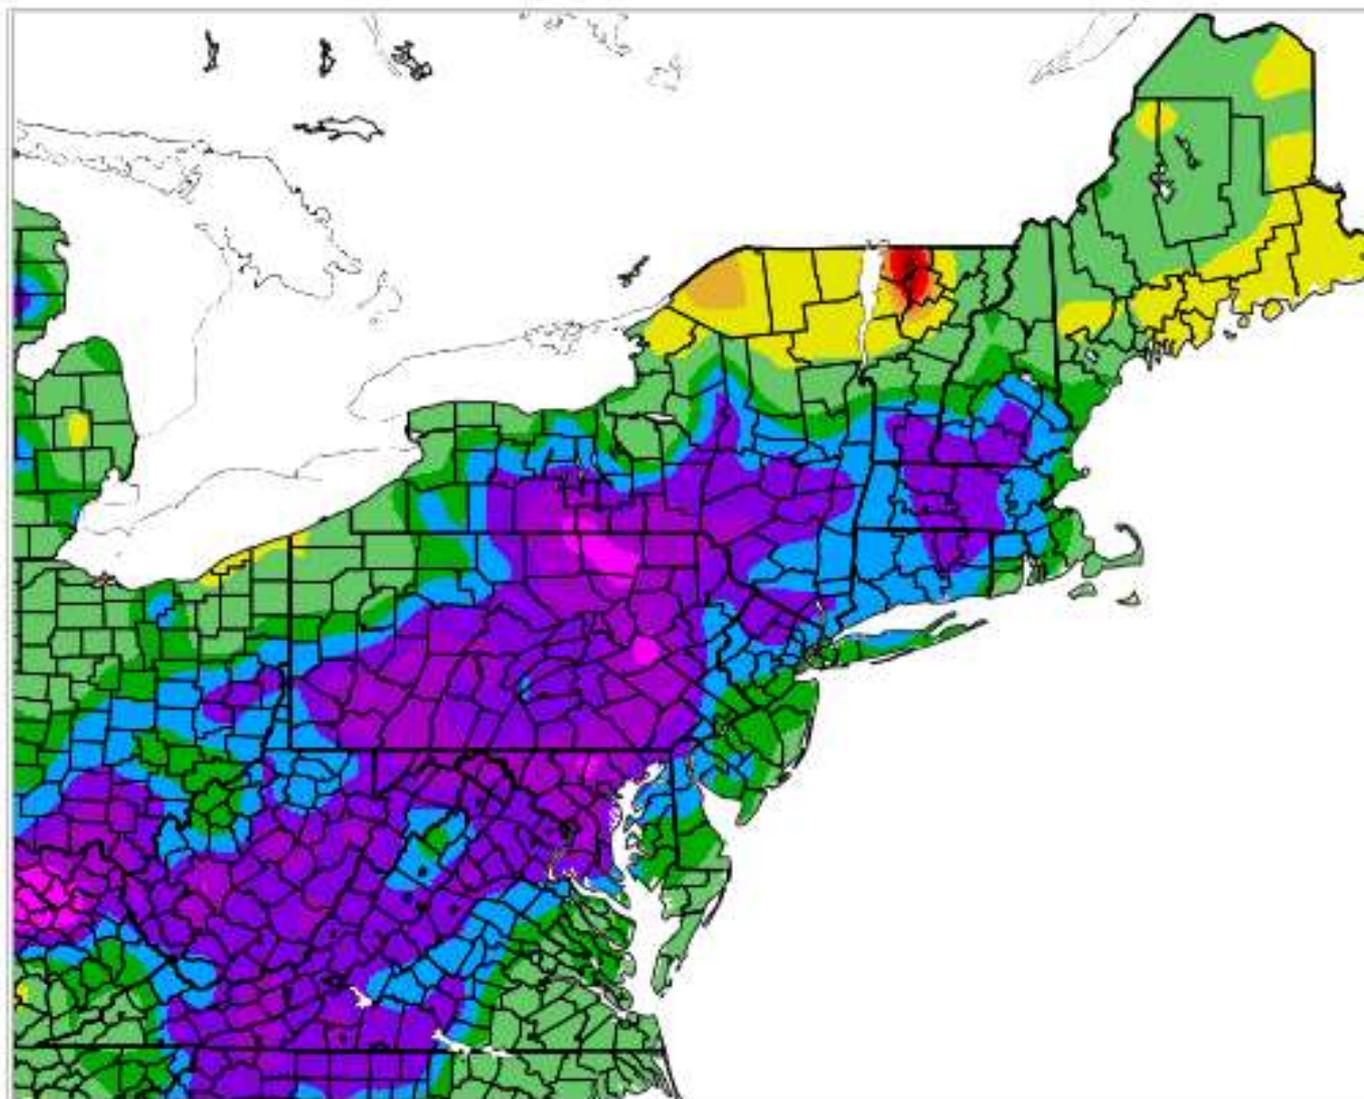
# 90 Day SPI

7/16/2018 – 10/13/2018

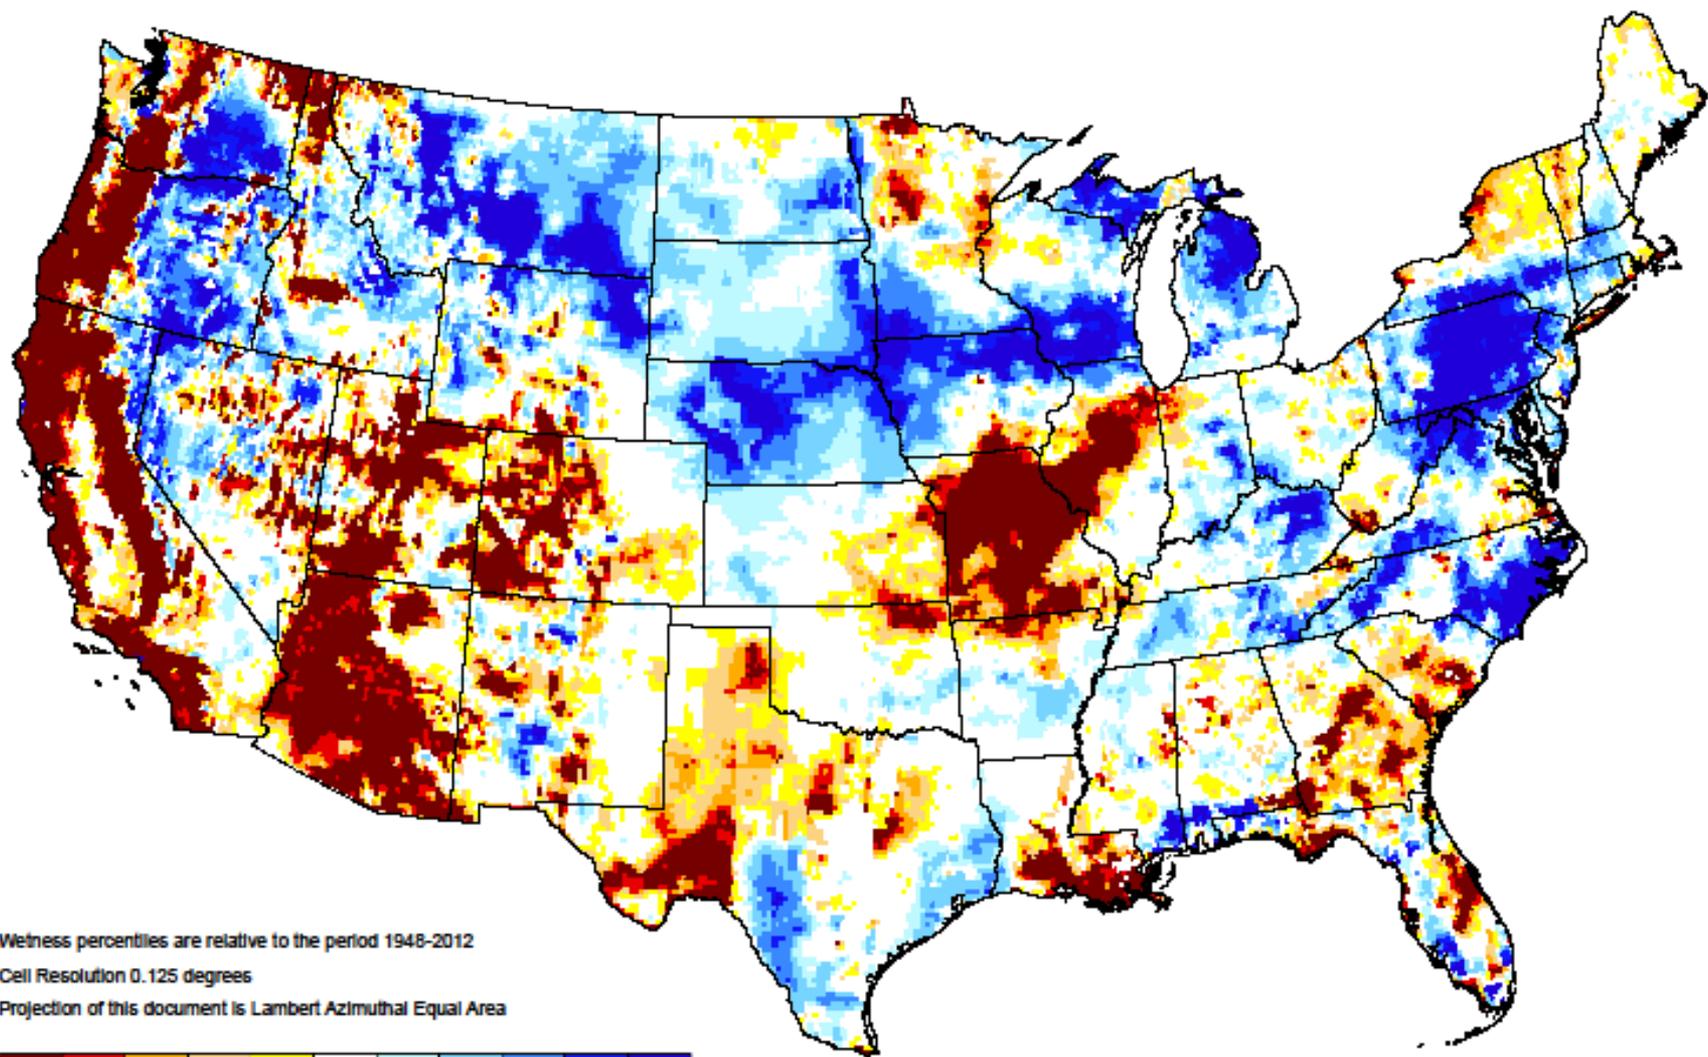
# GRACE-Based Shallow Groundwater Drought Indicator

October 08, 2018

Wetness percentiles are relative to the period 1948-2012

Cell Resolution 0.125 degrees

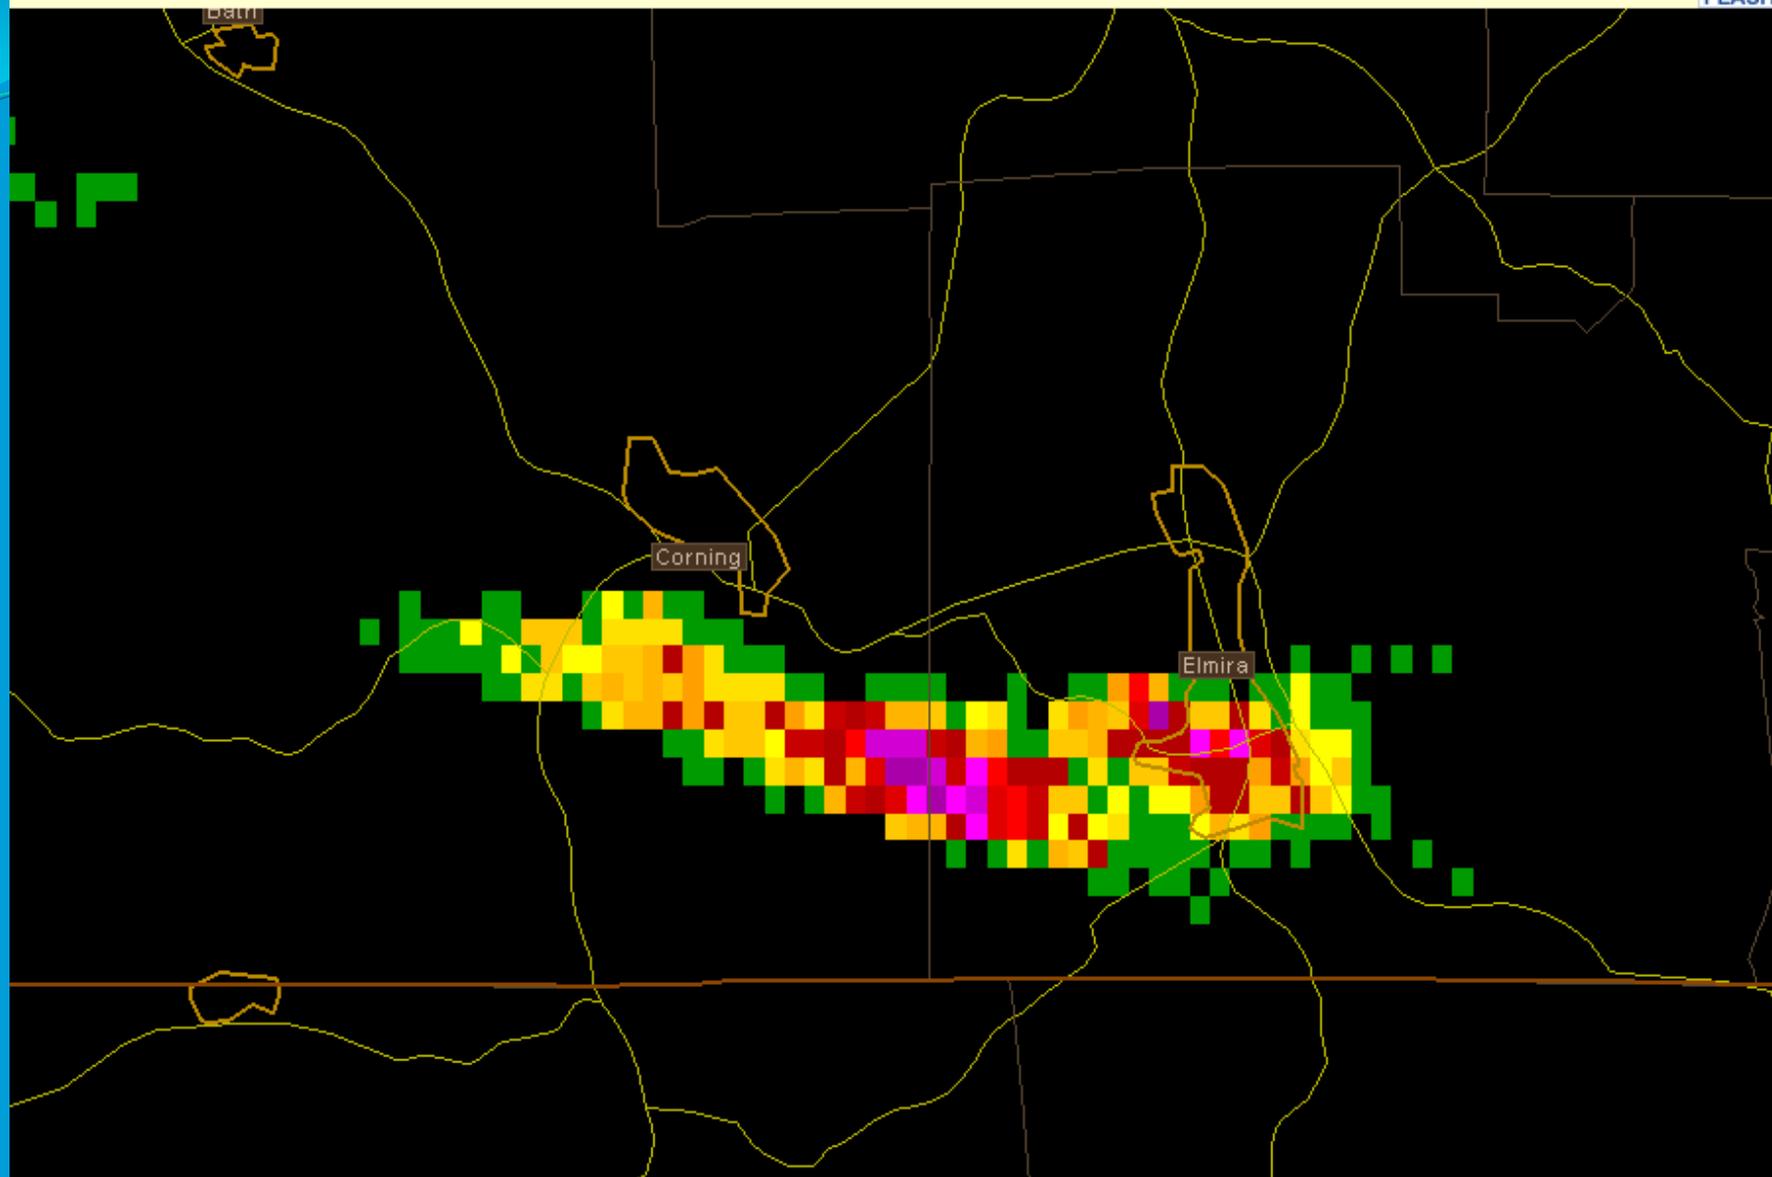
# Precipitation Accumulation Return Period

Valid: 07/14/2018 22:30:00 UTC

1-Hour

Return Period [yr]

- Initial portion of storm: 2 inches of rain/30-minute period
- Final portion of storm: 1.5 inches of rain/1-hour duration
- A gap between the end of the initial portion and the start of the final portion of the storm of approximately 1 hour occurred.

For the initial portion of the storm, 2 inches of rainfall over a 30-minute duration corresponds to a storm event with a 91-year return period. Refer to the interpolation below.

For the overall storm event, 3.5 inches of rainfall over a 2.5-hour duration corresponds approximately to a storm event with a 100-year return period. Refer to the information below.

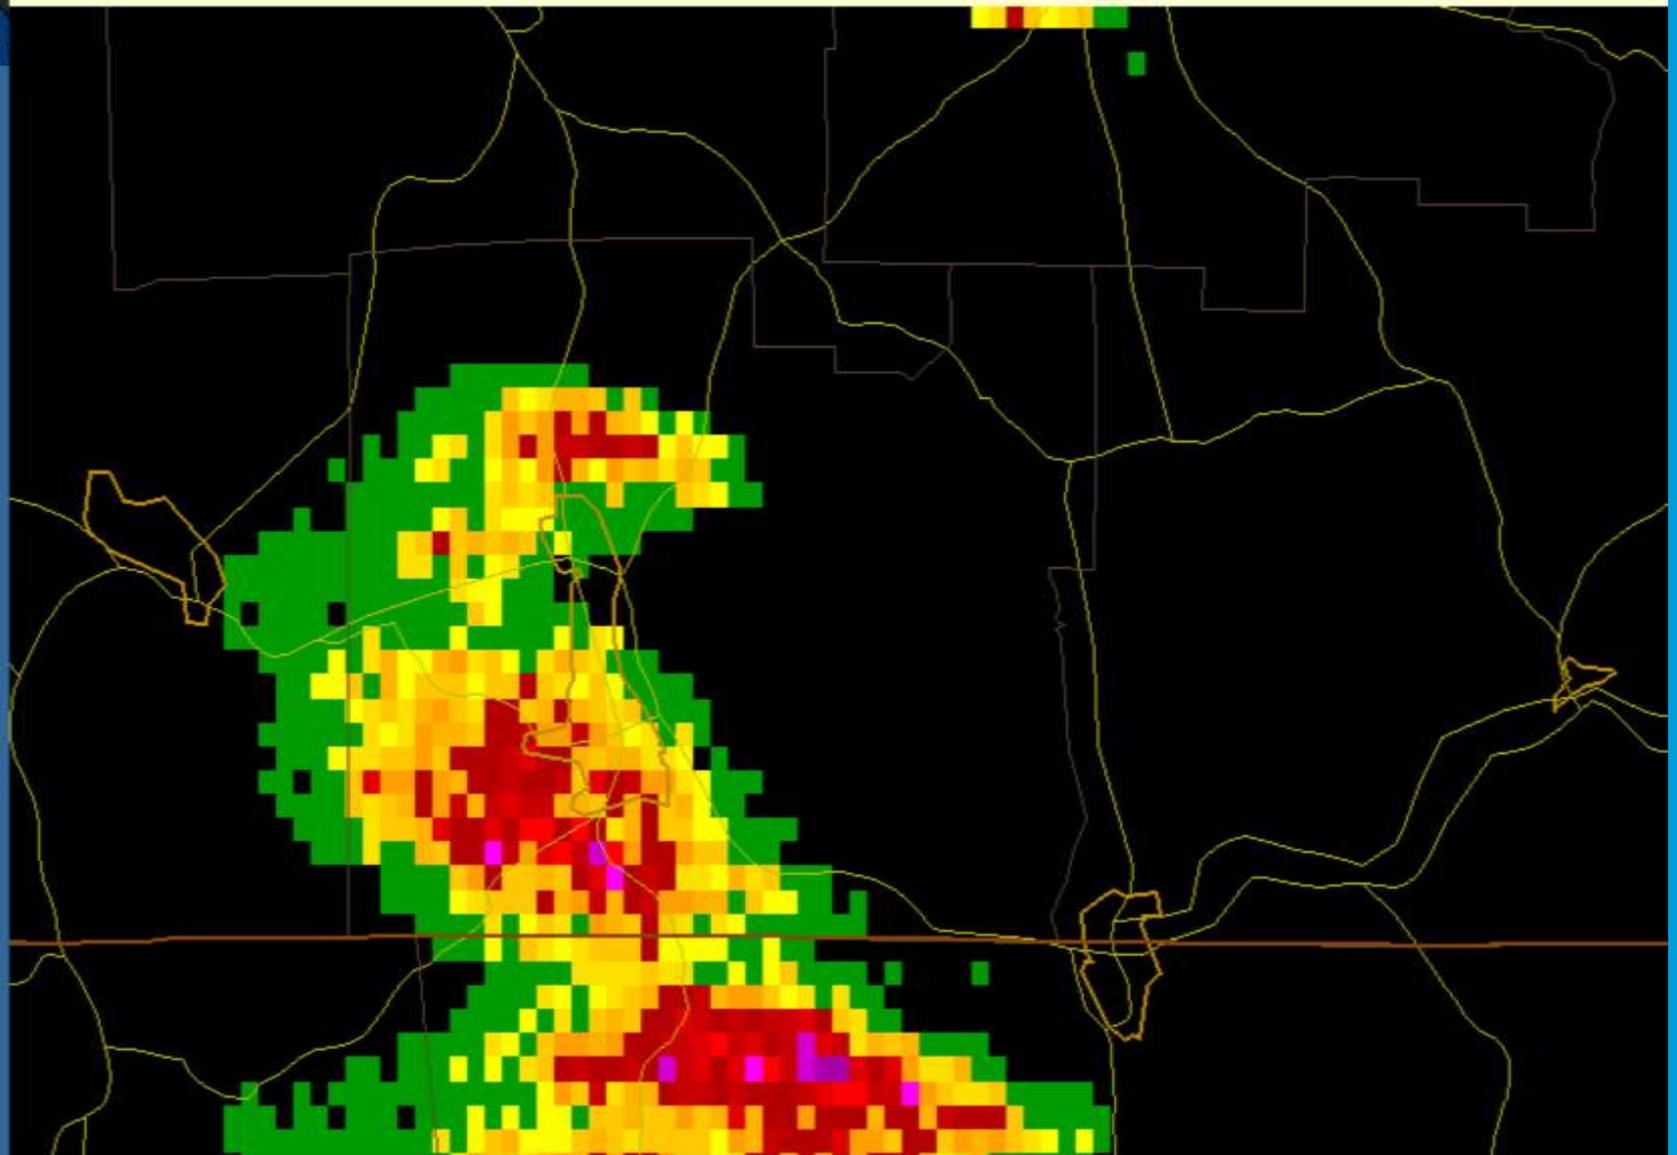
# Precipitation Accumulation Return Period

Valid: 08/13/2018 18:30:00 UTC

3-Hour

Return Period [yr]

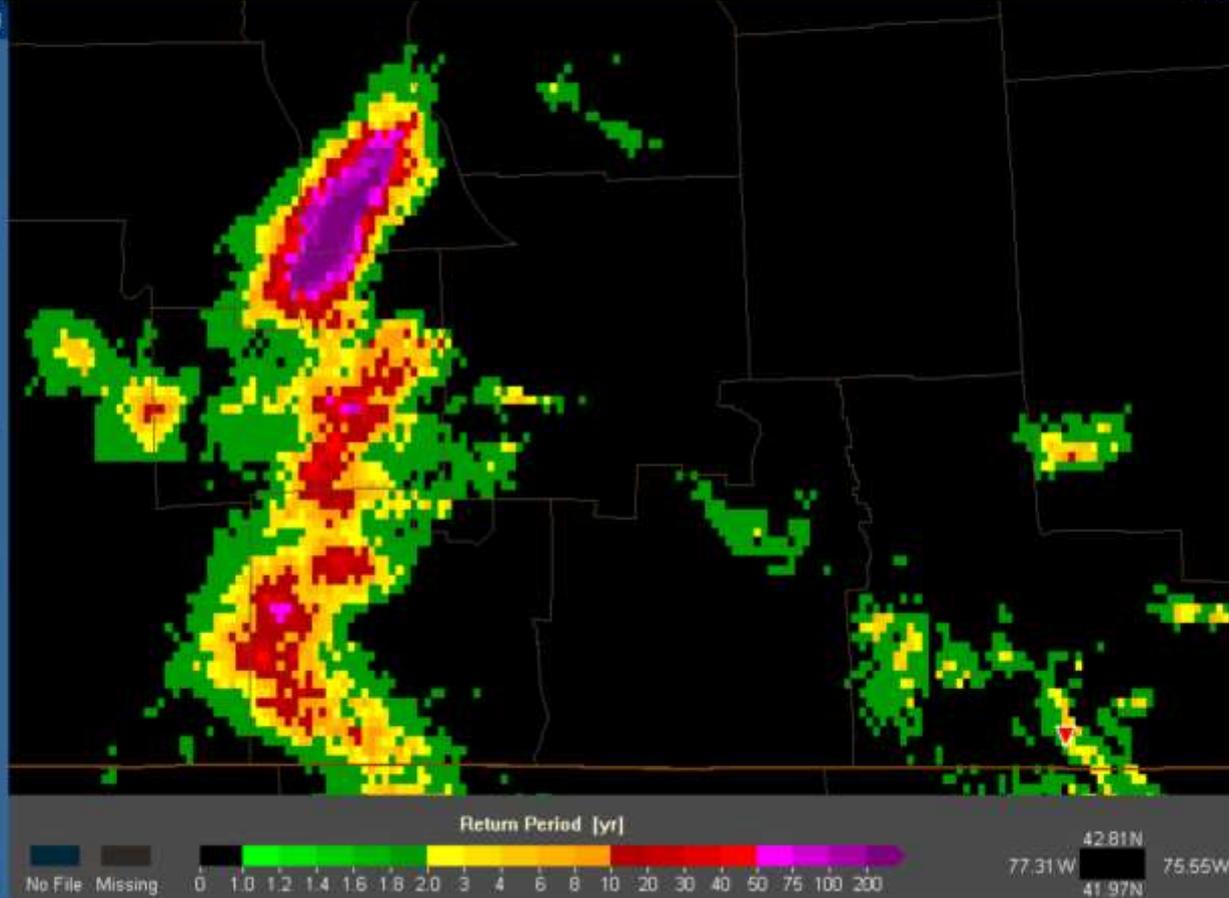
## Precipitation Accumulation Return Period 24-Hour

Valid: 08/14/2018 09:00:00 UTC

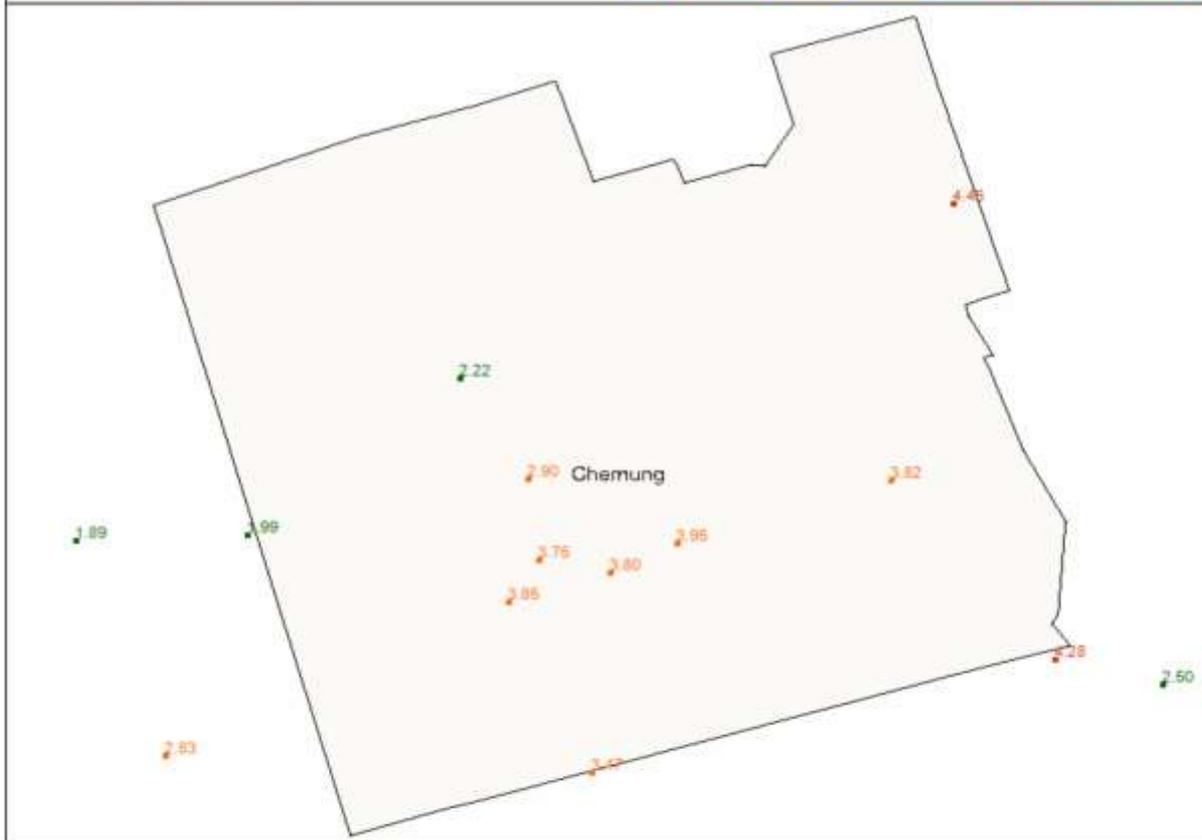
Chemung County, New York 9/18/2018

Daily Precipitation (inches x.xx), for the 24 hour period ending ~7:00 am

0.0 Trace 0.01 - 0.22 0.23 - 0.44 0.45 - 1.11 1.12 - 2.67 2.68 - 4.01 4.02 - 4.46

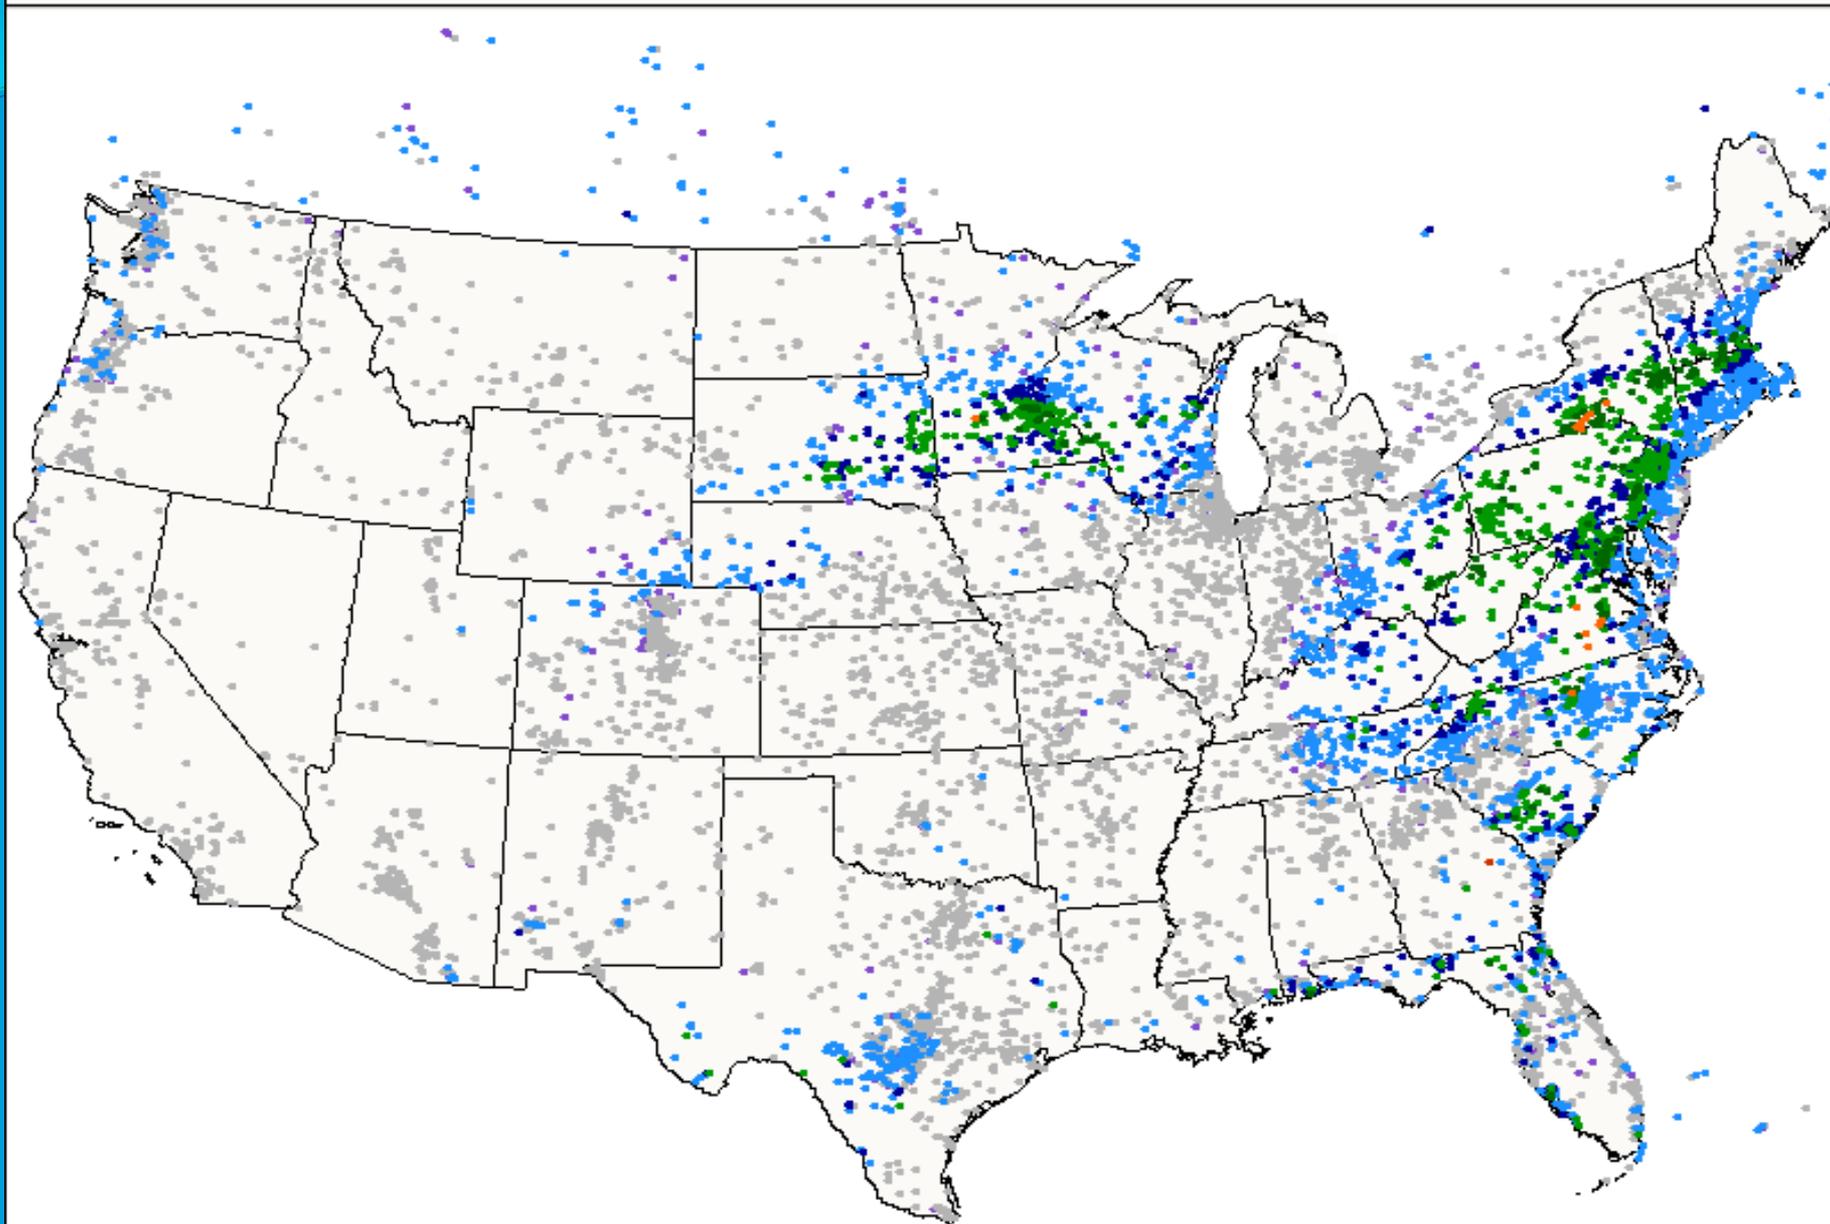
USA 9/18/2018

Daily Precipitation (inches x.xx), for the 24 hour period ending ~7:00 am

0.0 Trace 0.01 - 0.33 0.34 - 0.66 0.67 - 1.64 1.65 - 3.93 3.94 - 5.89 5.90 - 6.53

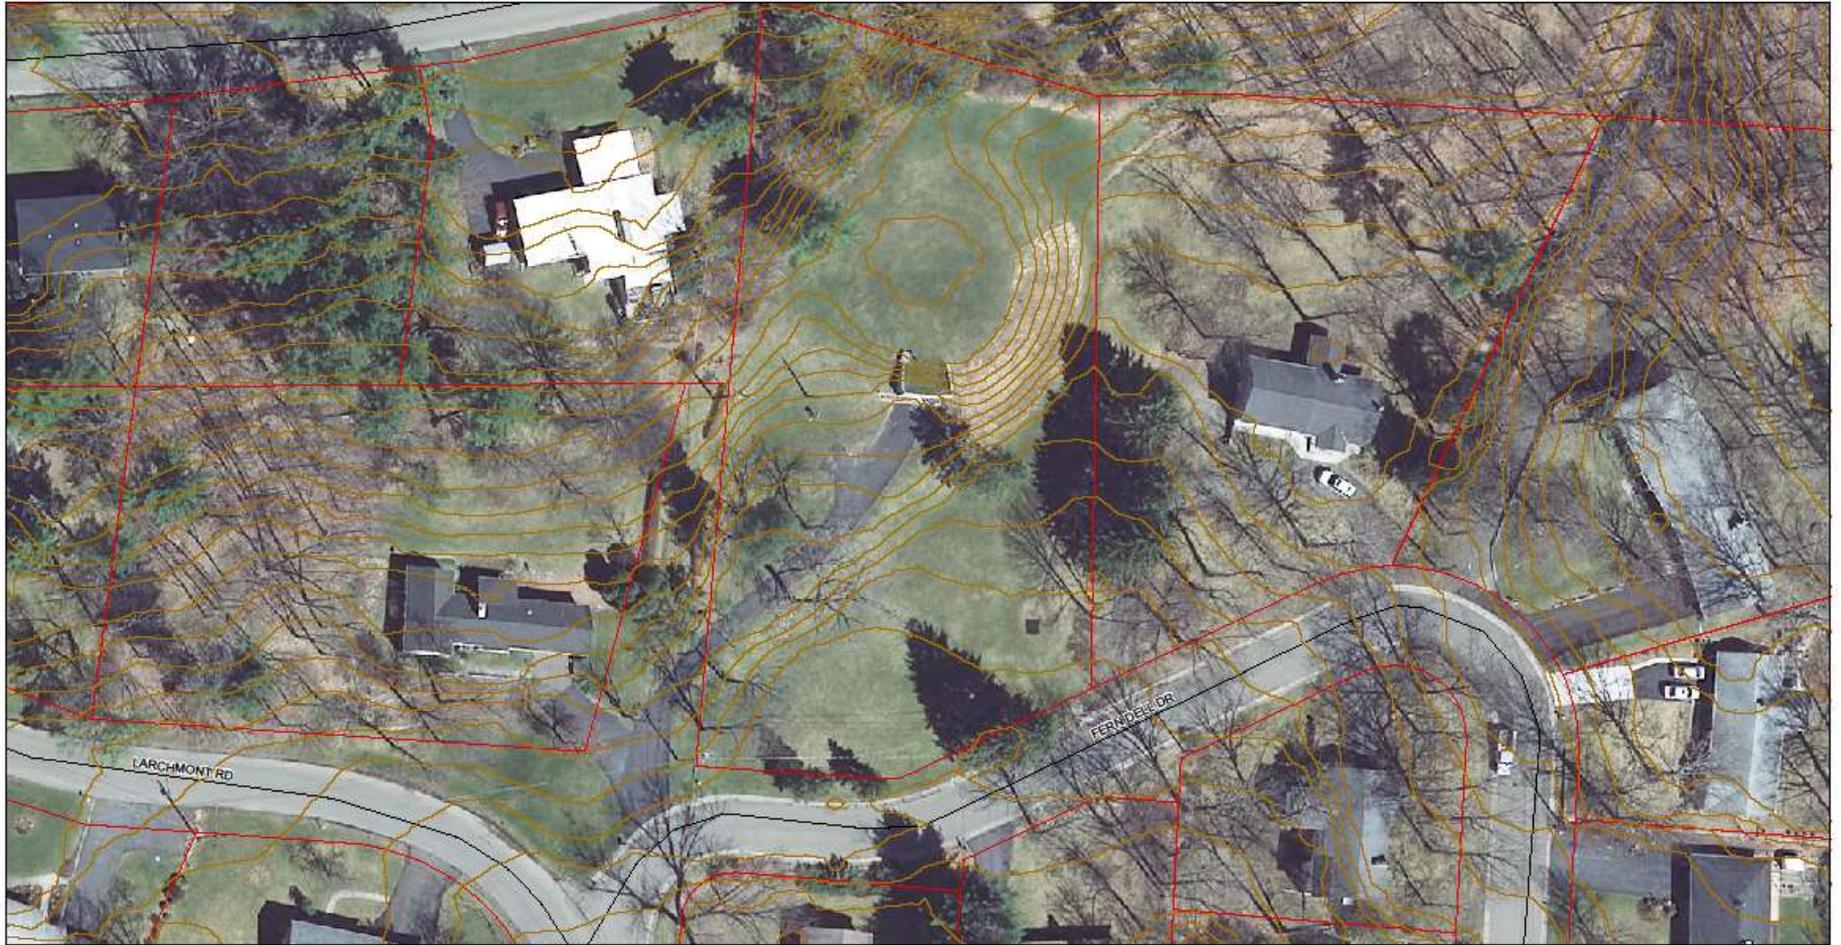
Aerial Photograph Mapping
Fern Dell Drive Town of Elmira, New York

1 in = 50 ft

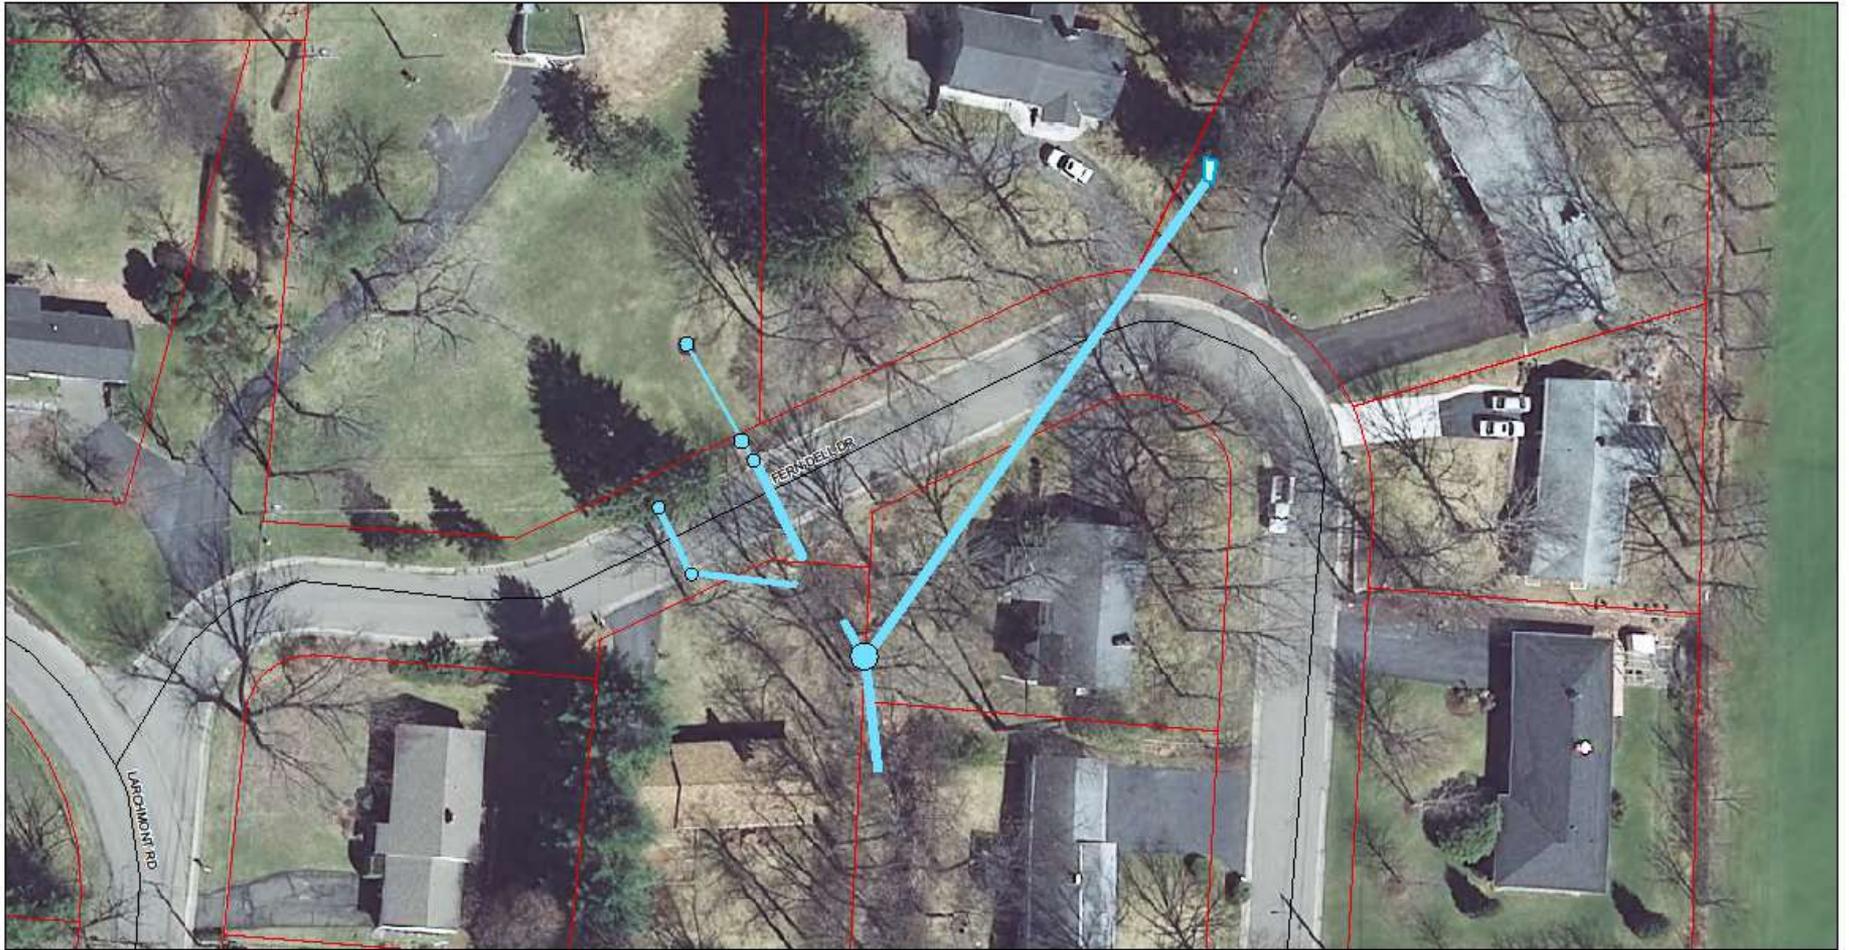
Storm Sewers - Schematic Plan
Fern Dell Drive Town of Elmira, New York

1 in = 40 ft

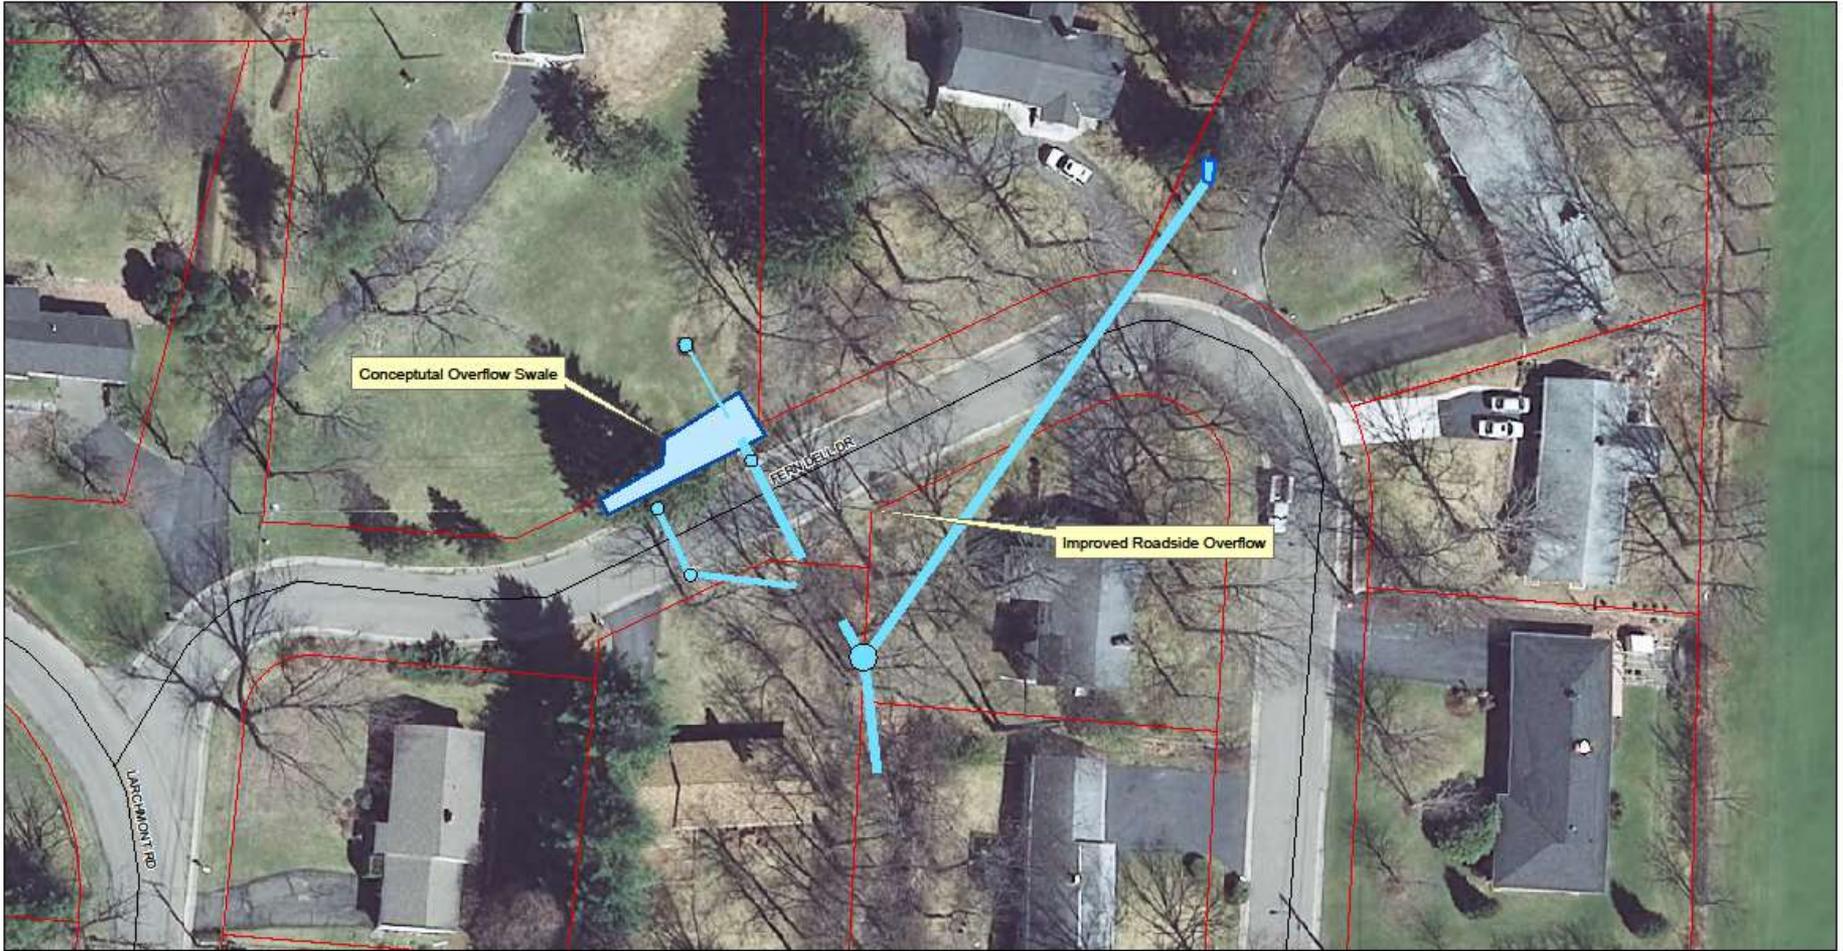
Conceptual Improvement - Overflow Swale

Fern Dell Drive  
Town of Elmira, New York

1 in = 40 ft

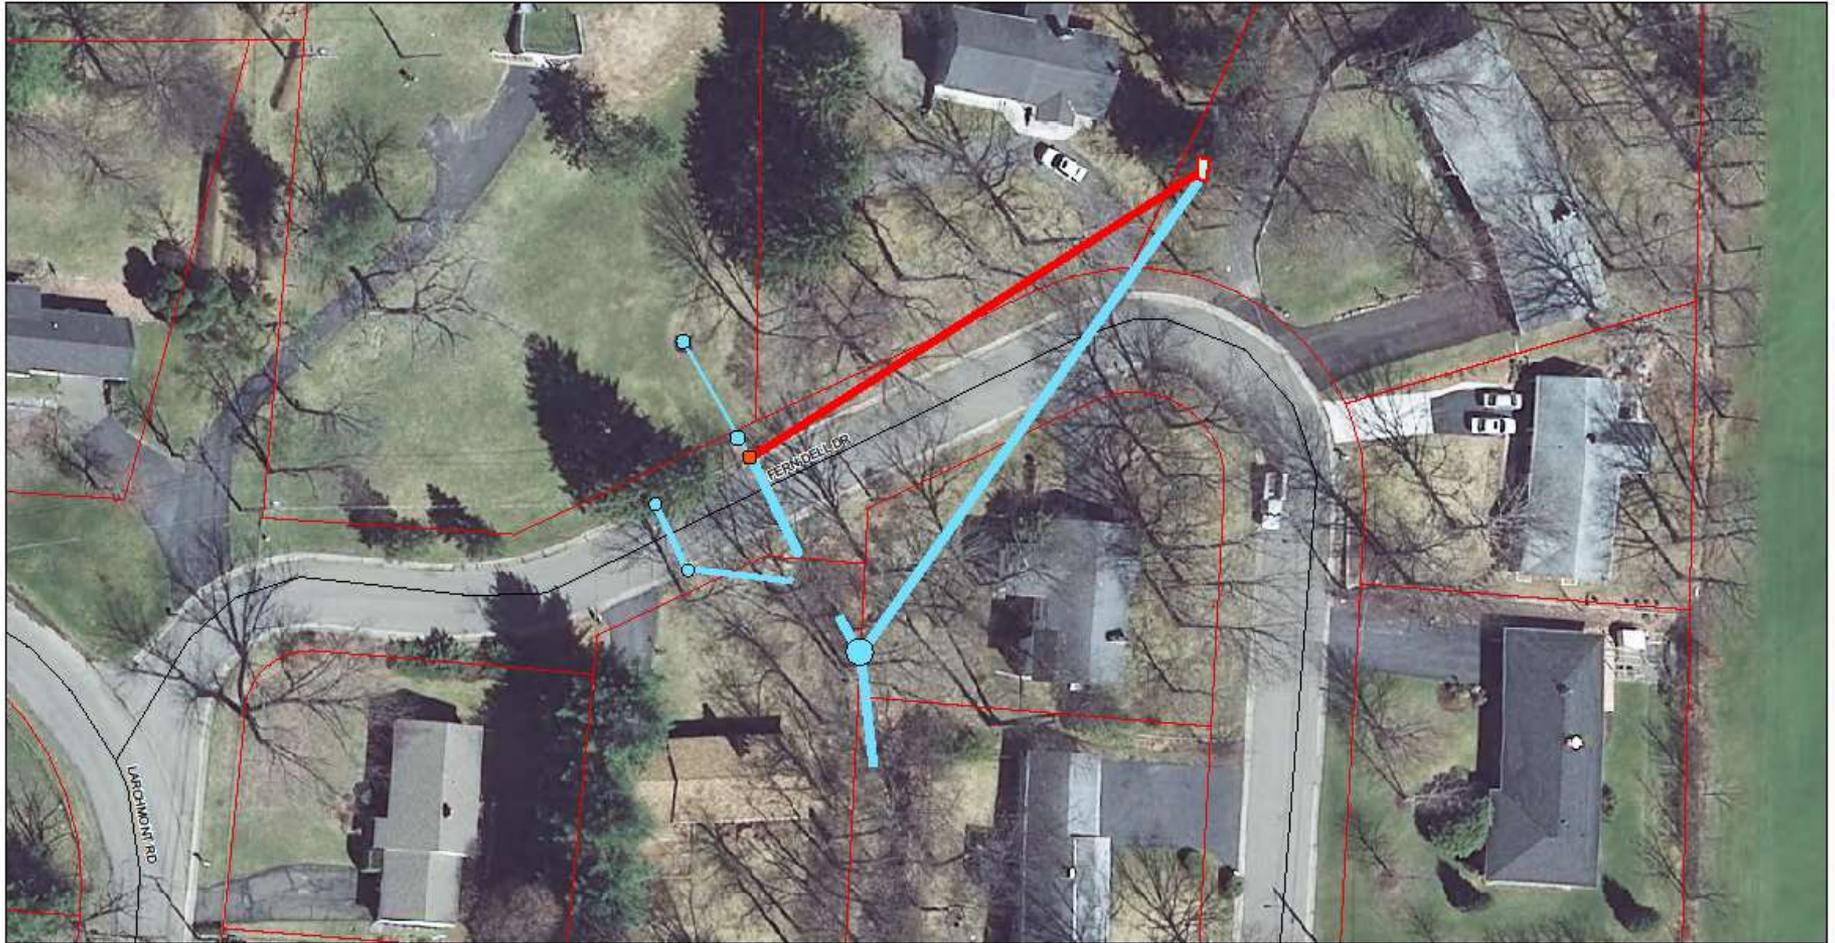
Conceptual Improvement
Fern Dell Drive Town of Elmira, New York

1 in = 40 ft
