# Stormwater Considerations

## – West Elmira

# Fern Dell Drive Stormwater System

# Comprehensive Storm Drainage Studies

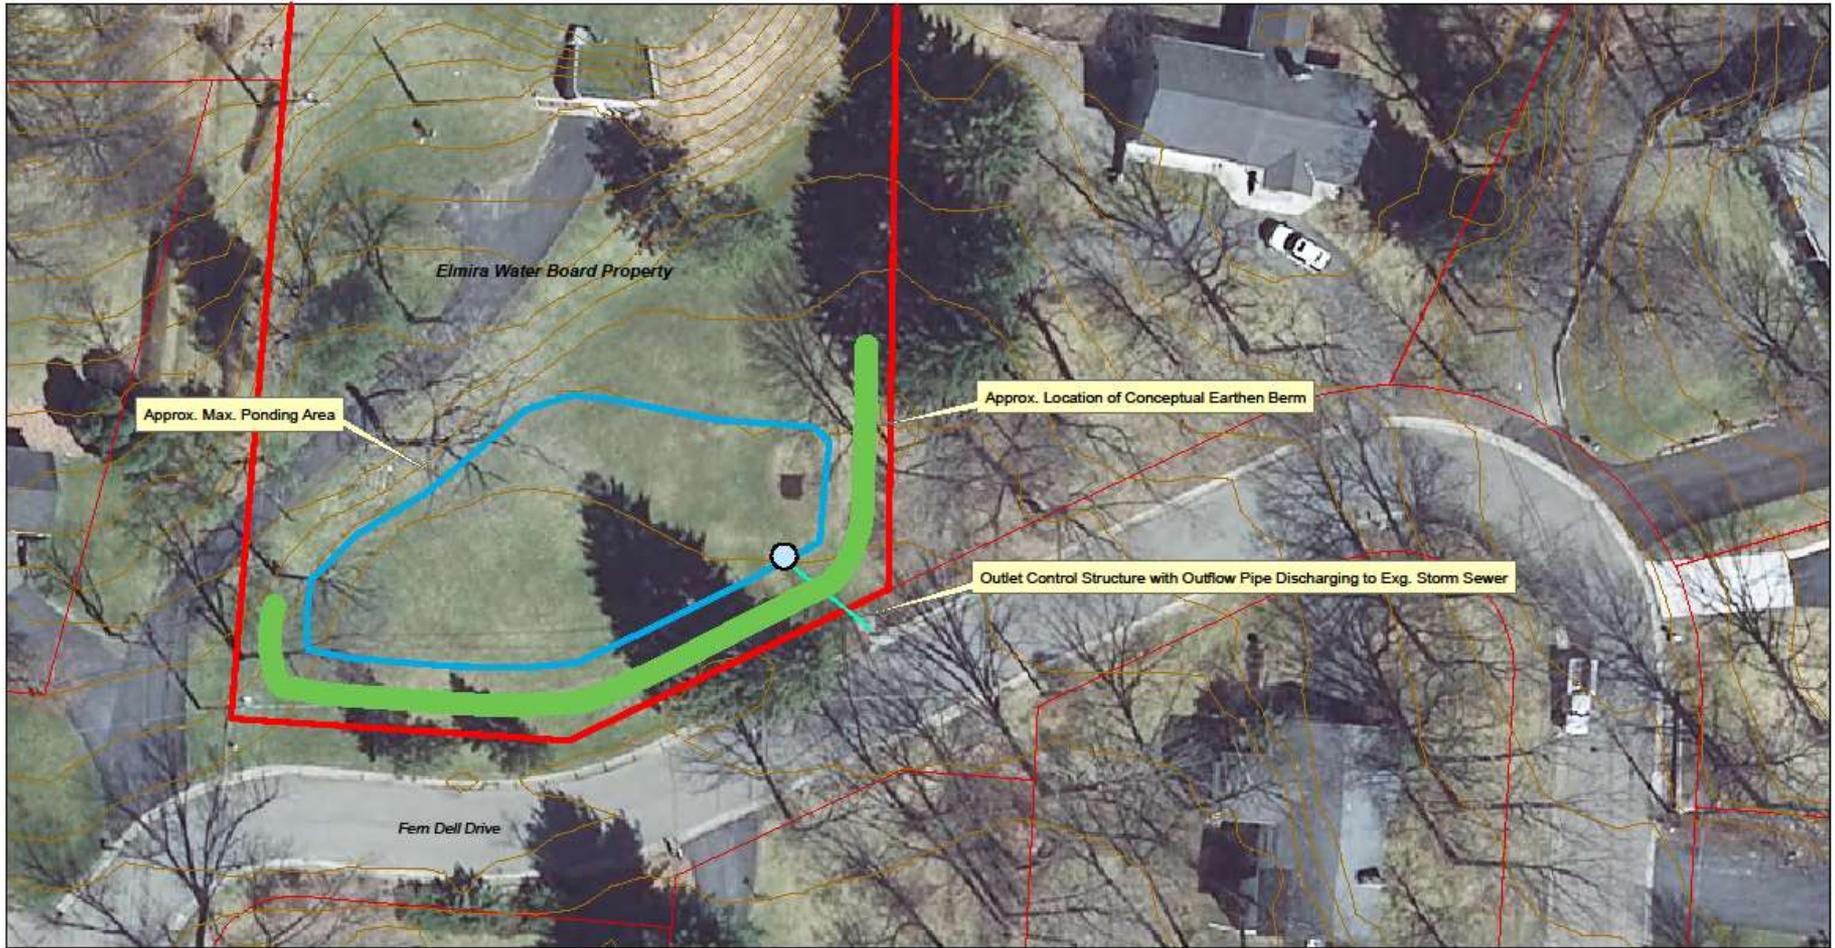
Conceptual Stormwater Detention Basin
Elmira Water Board Property on Fern Dell Drive Town of Elmira, Chemung County, New York

1 in = 30 ft

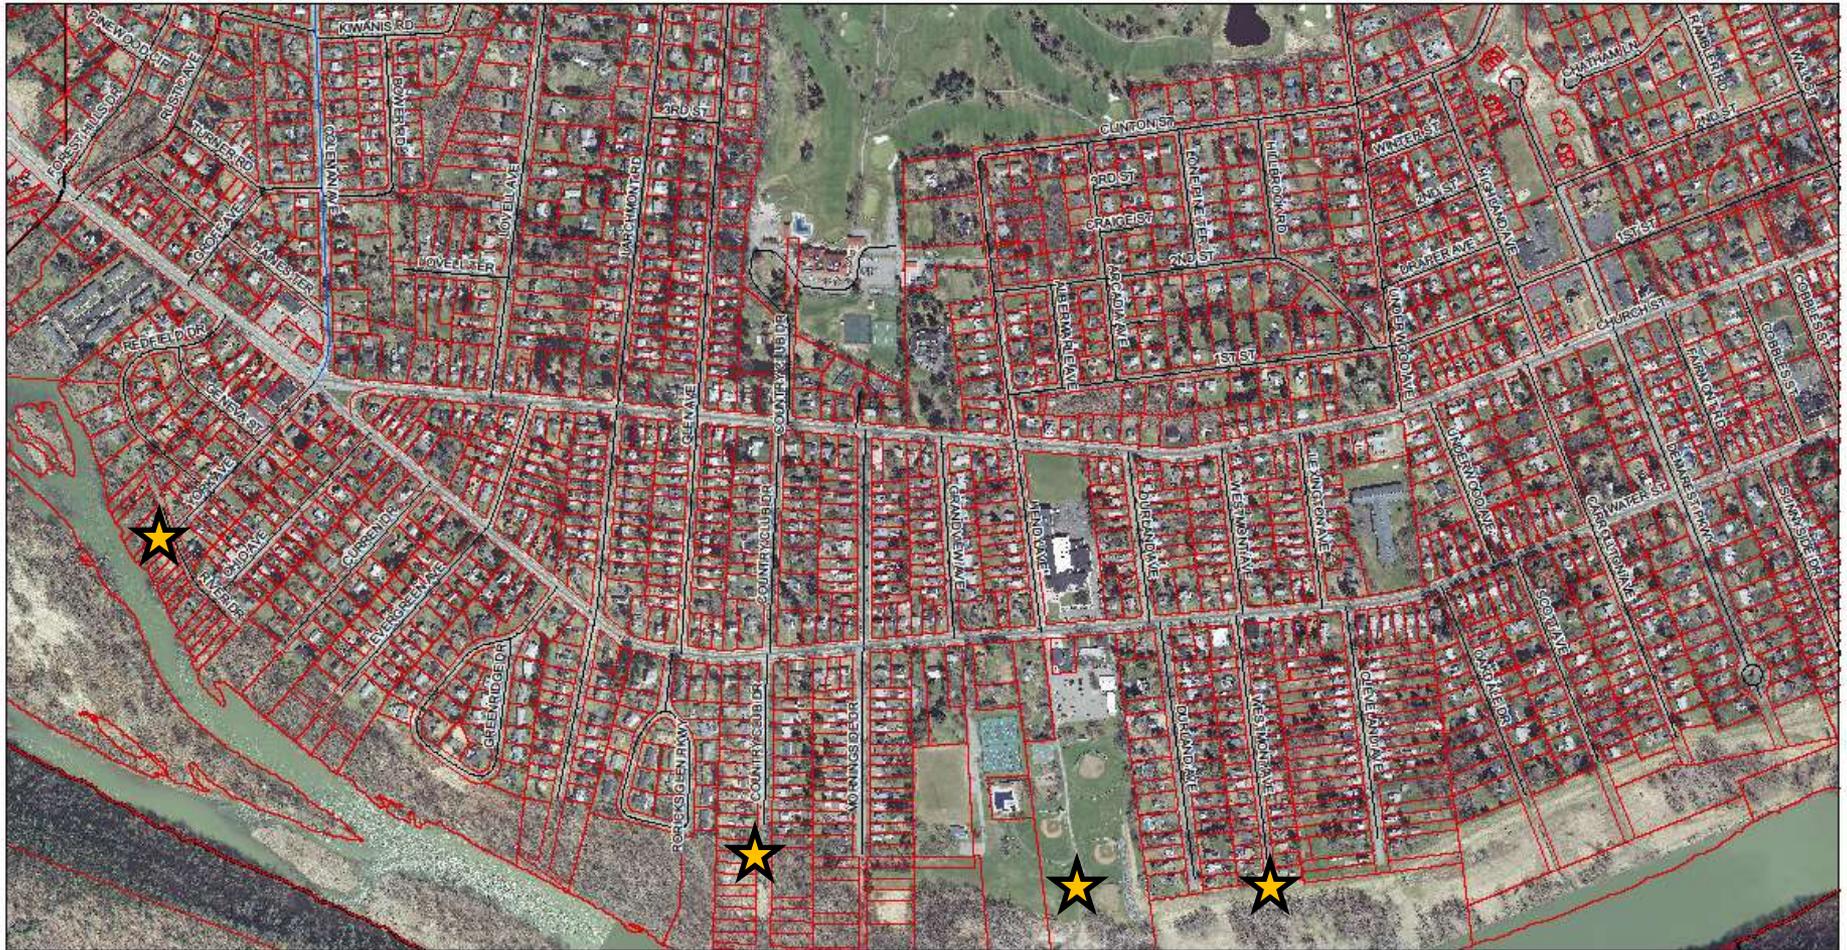
Aerial Photograph Mapping
West Elmira Town of Elmira, New York

1 in = 500 ft

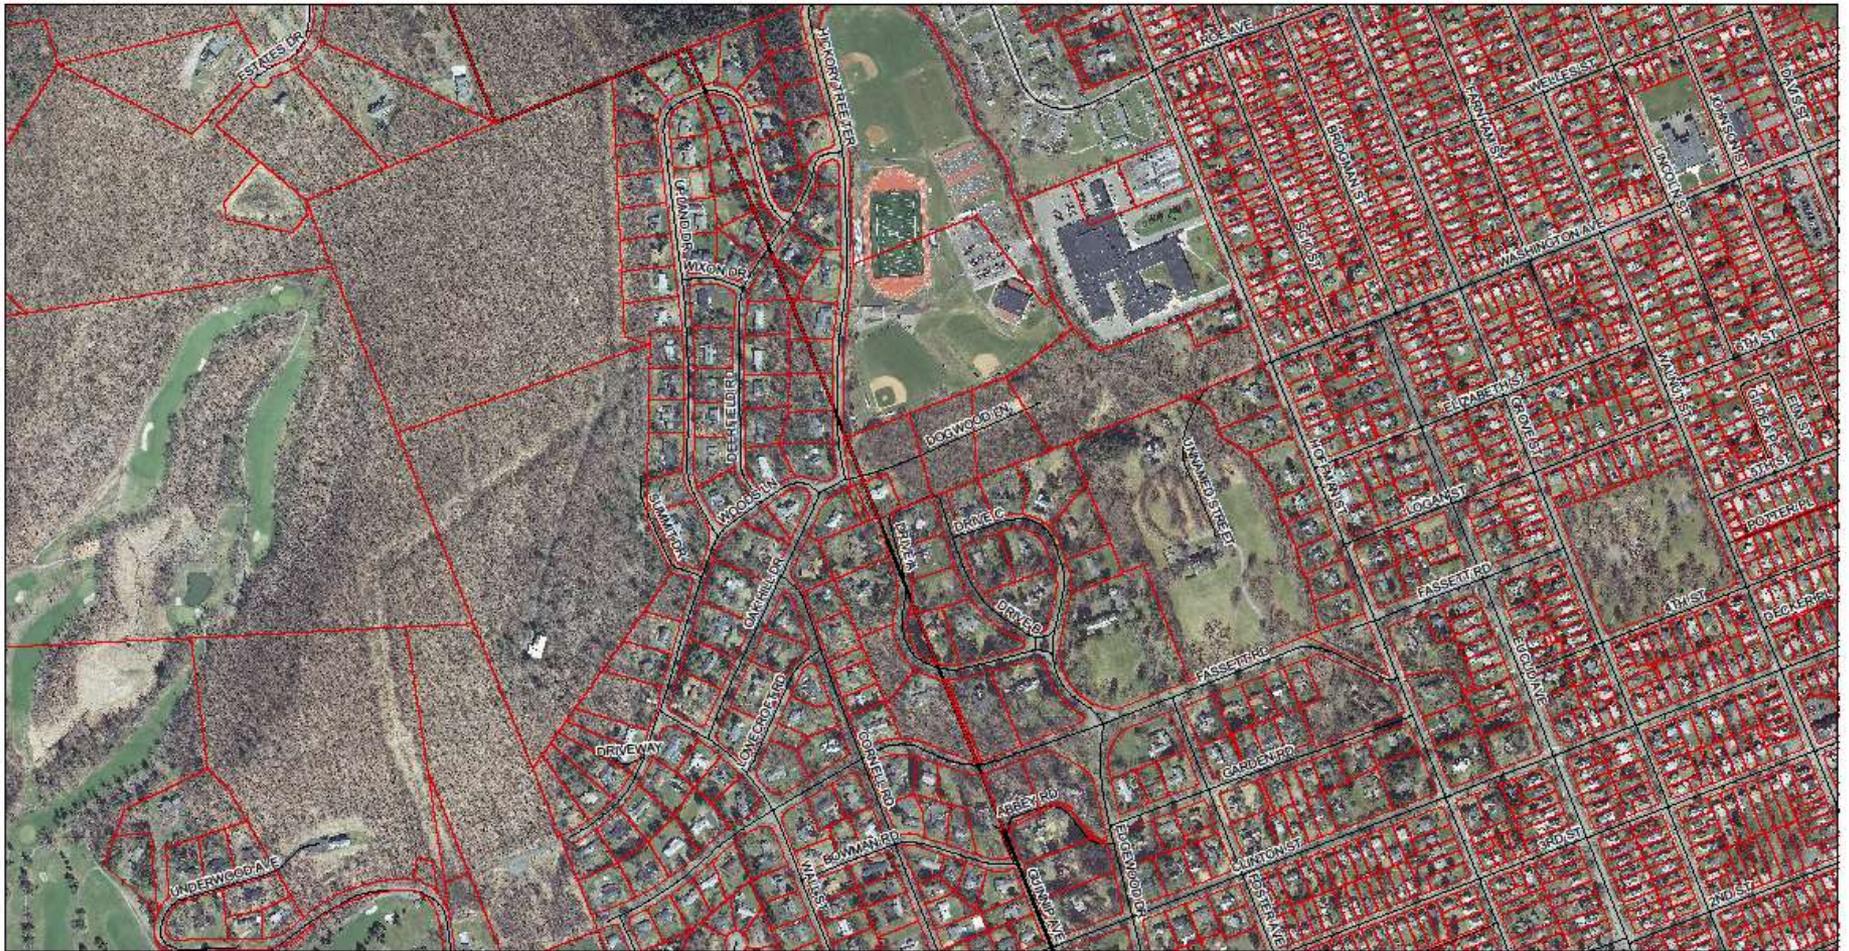
Aerial Photograph Mapping
West Elmira Town of Elmira, New York

1 in = 500 ft
